▣ 악취방지덮개 사진(중량물재생센터)

▣ 악취방지덮개 사진(서남물재생센터)

▣ 악취방지덮개 사진(탄천물재생센터)

▣ 악취방지덮개 사진(난지물재생센터)

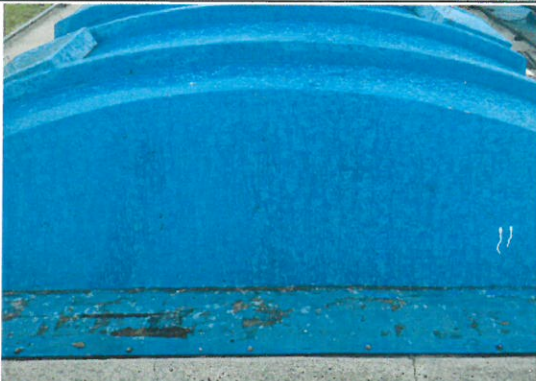
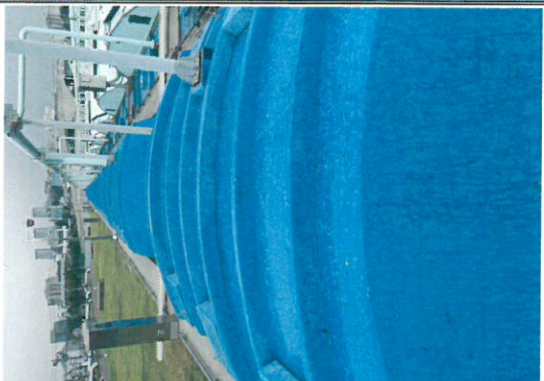
1,2처리장 일차침전지(일부)

규격	3300(W) × 7000(L) × 1000(H)	
재질	FRP(프레임 없음, 설치년도 2007)

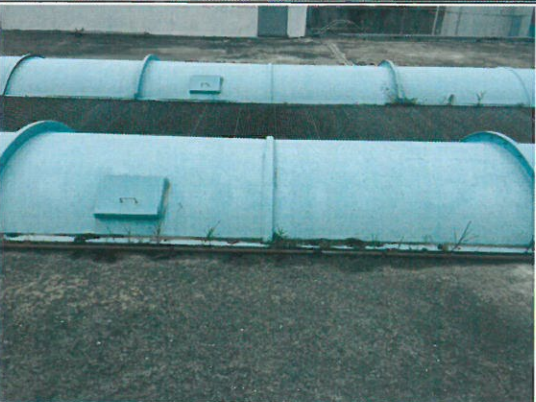
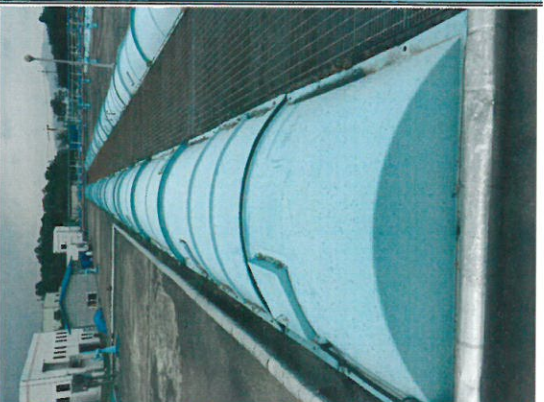
3처리장 일차침전지

규격	2000(W) × 50000(L) × 400(H)	
재질	FRP(프레임 없음, 설치년도 2006)

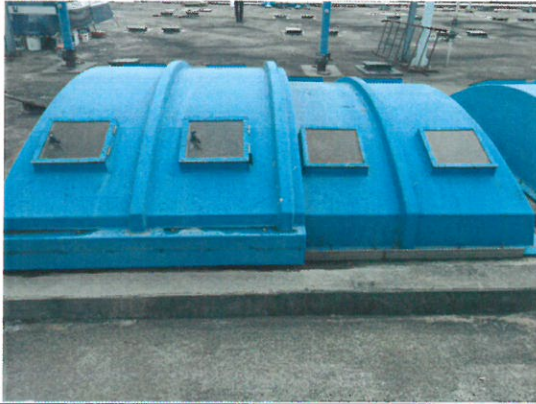
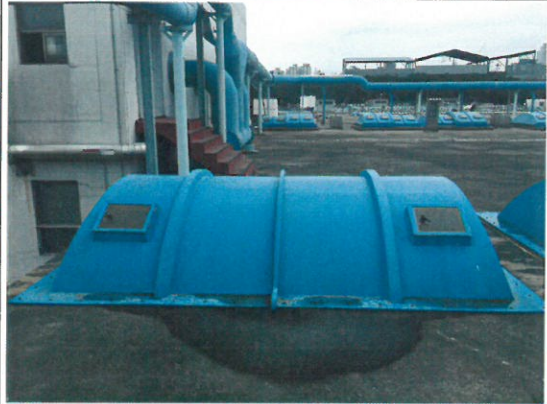
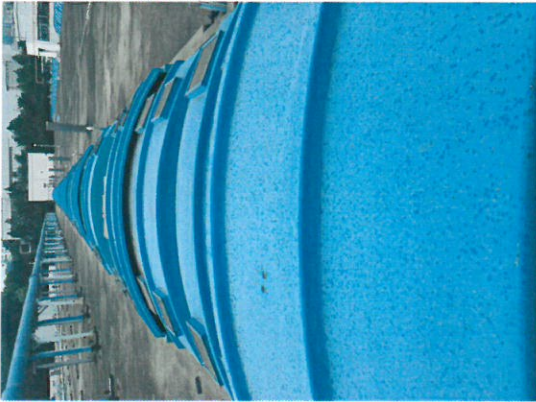
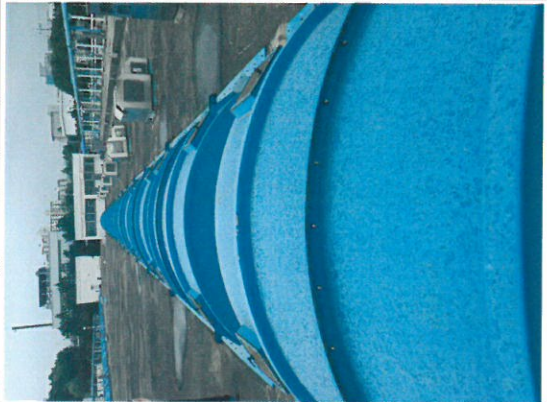
4처리장 일차침전지

규 격 3300(W) × 4400(L) × 400(H)

재 질 FRP(프레임 없음, 설치년도 2006)

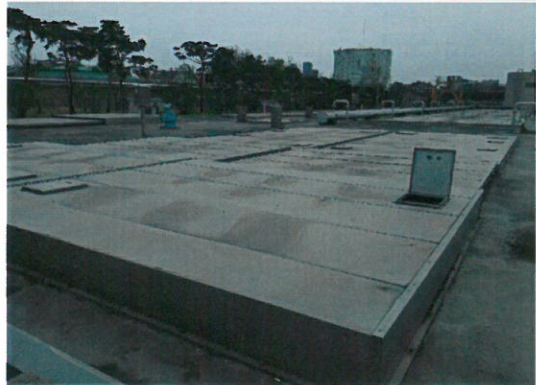
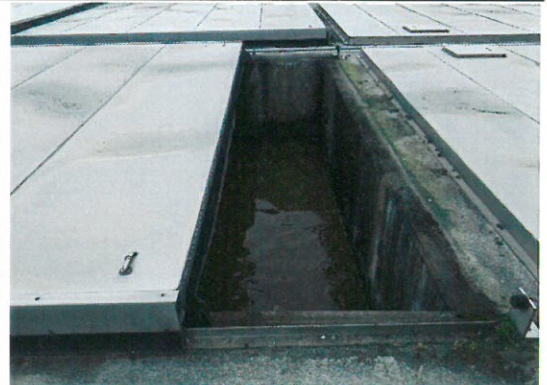
1,2처리장 생물반응조

규 격 2500(W) × 7300(L) × 200(H)

재 질 AL(프레임 + 덮개 등 전체 AL사용)(전반적으로 상태 양호, 설치년도 2007)

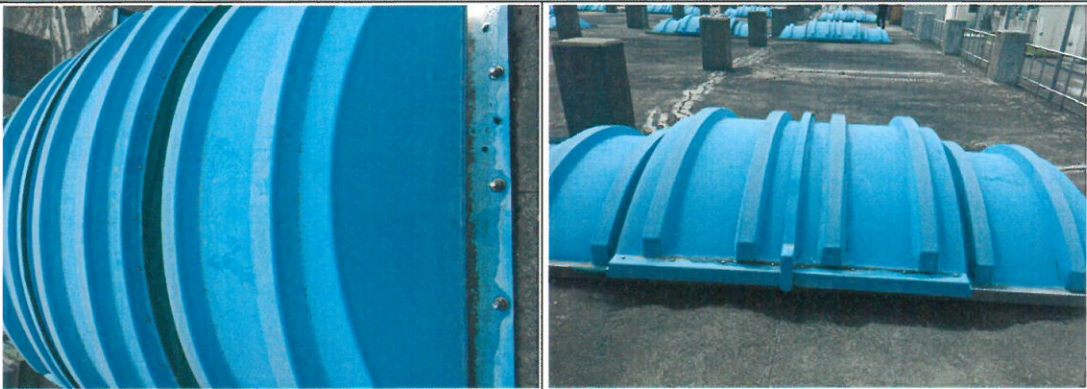
2처리장 일차침전지

<p>규격</p>	<p>2200(W) × 4200(L) × 700(H)</p>	
<p>재질</p>	<p>FRP(프레임 없음, 설치년도 1999)</p>

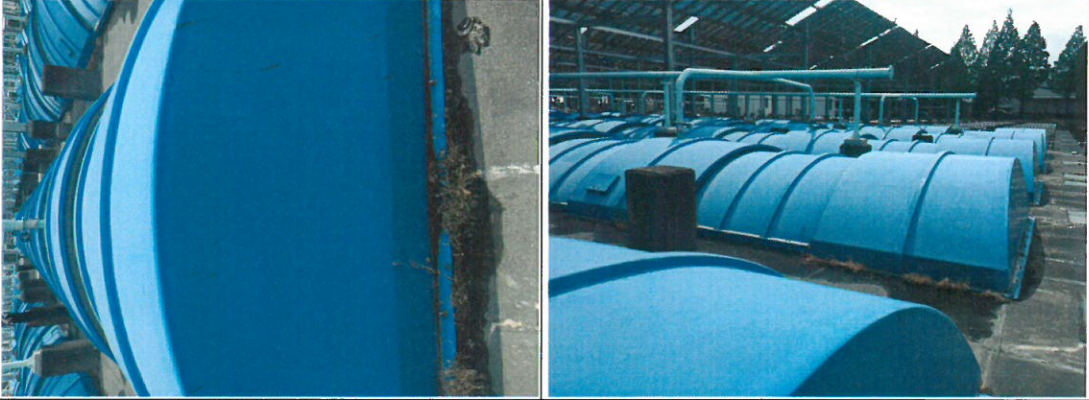
2처리장 반류수처리시설

<p>규격</p>	<p>3500(W) × 22000(L) × 1200(H)</p>	
<p>재질</p>	<p>FRP (프레임 없음, 설치년도 2011)</p>

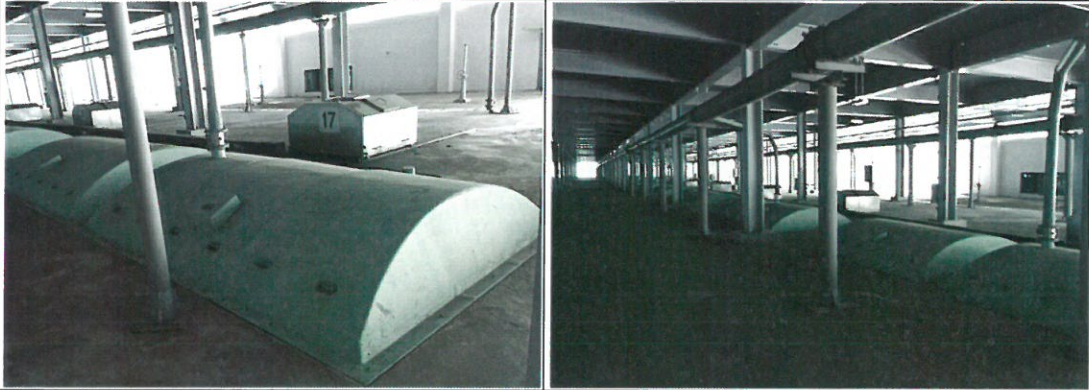
1처리장 일차침전지

<p>규격</p>	<p>1500(W) × 2500(L) × 600(H)</p>	
<p>재질</p>	<p>FRP(프레임 없음, 설치년도 1987)</p>

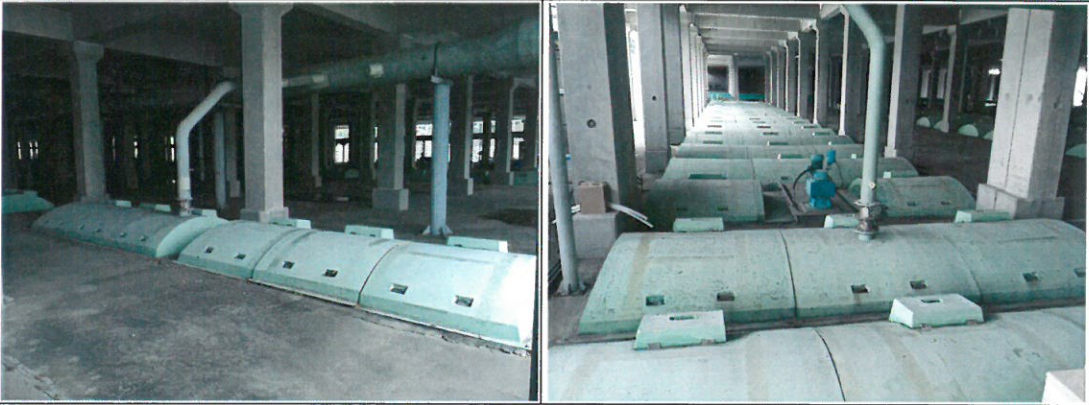
2처리장 일차침전지, 생물반응조

<p>규격</p>	<p>1200(W) × 4000(L) × 600(H)</p>	
<p>재질</p>	<p>FRP(프레임 없음, 설치년도 1995, 1998)</p>

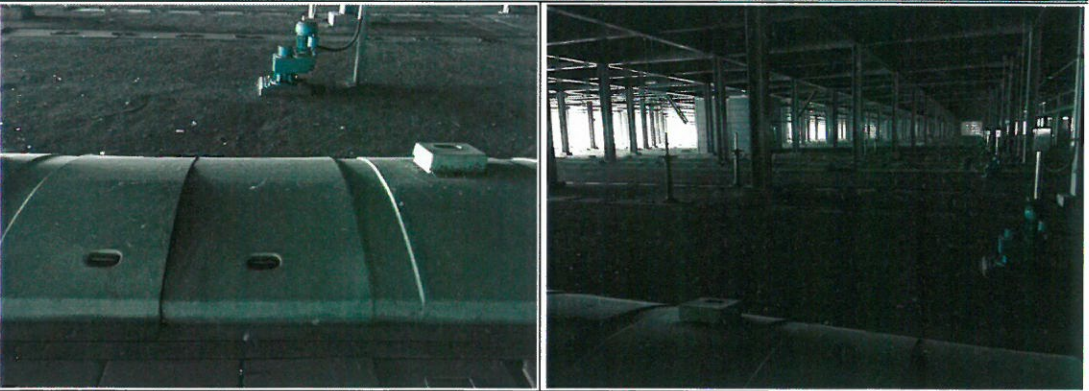
1처리장 생물반응조

<p>규격</p>	<p>1500(W) × 5000(L) × 300(H)</p>	
<p>재질</p>	<p>FRP(프레임 없음, 설치년도 1987)</p>

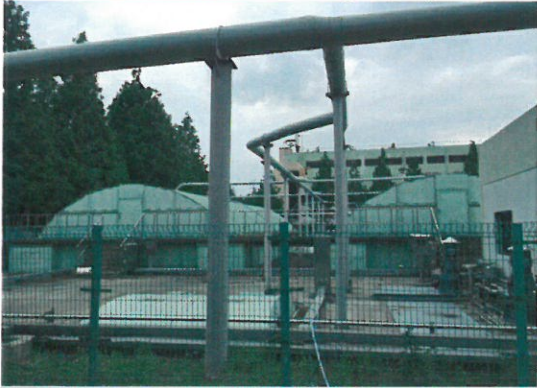
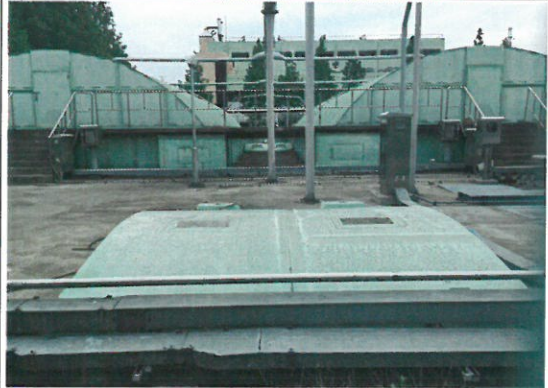
1처리장 반류수 처리시설

규 격 2400(W) × 1700(L) × 600(H)

재 질 FRP(프레임 없음, 설치년도 1995, 1998)

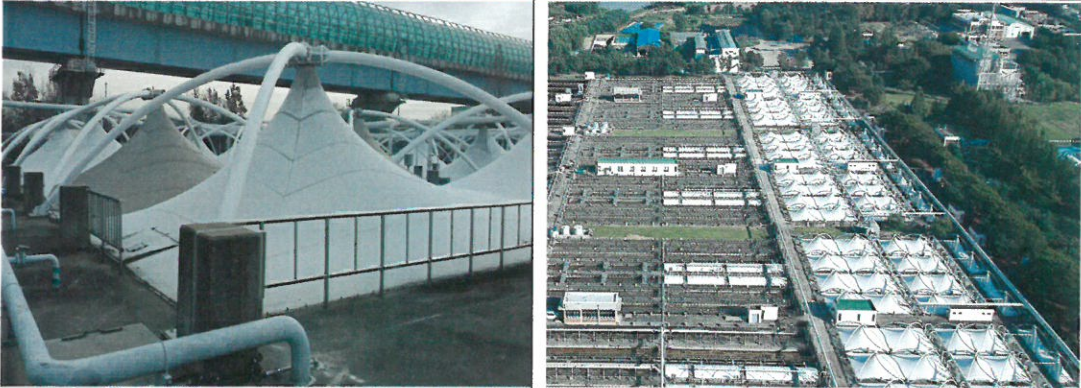
1처리장 일차침전지

<p>규격</p>	<p>11500(W) × 11500(L) × 2500(H)</p>
<p>재질</p>	<p>PVDF막(프레임 없음, 설치년도 2002)</p>
