# 구리암사대교 하자점검 결과

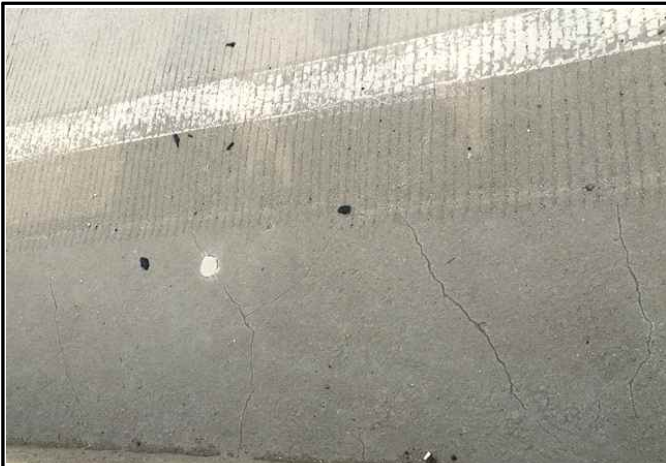
사진 1 : LMC 포장 균열(RAMP-B, C, A, F)

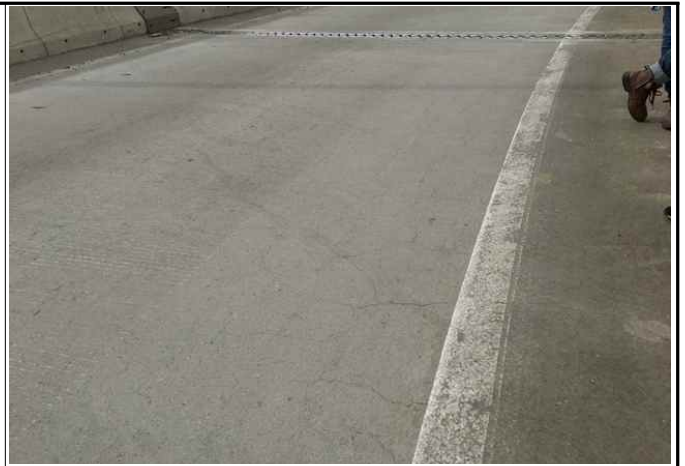
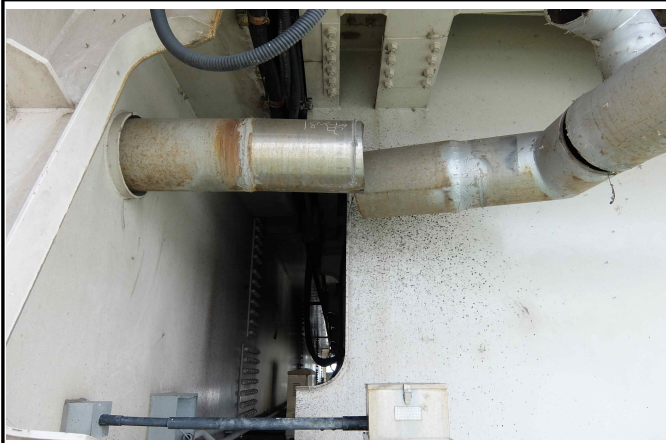
사진 2 : 배수관 탈락 및 누수  
(MP8, MP10, EP6 등)

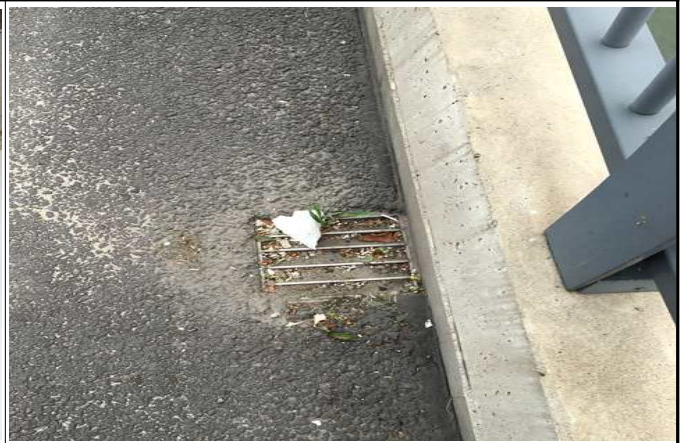
사진 3 : 배수관 토사 및 이물질 퇴적  
(MP6, MP7, MP12)

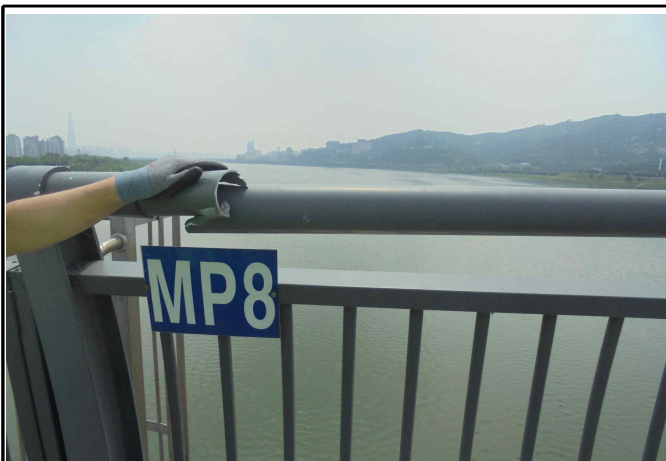
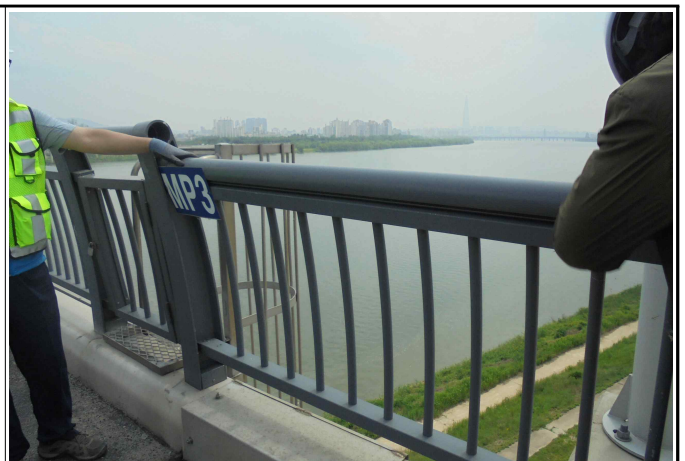
사진 4 : 난간 이탈(MP3, MP5, MP8 등 )

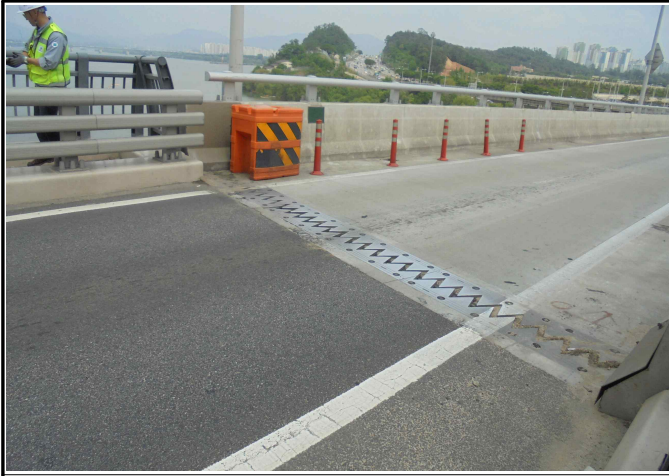
사진 5 : 신축이음 파손(MP3, MP10, FA2)

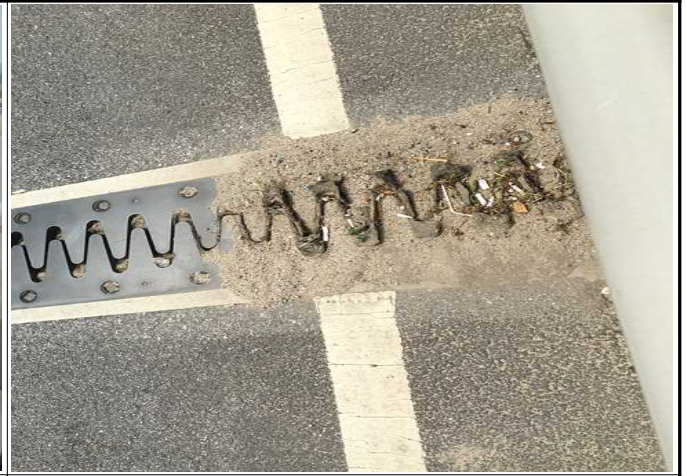
사진 6 : 신축이음 토사 퇴적(MP12)
