# 성동교차로 사거리 (현황+개선)

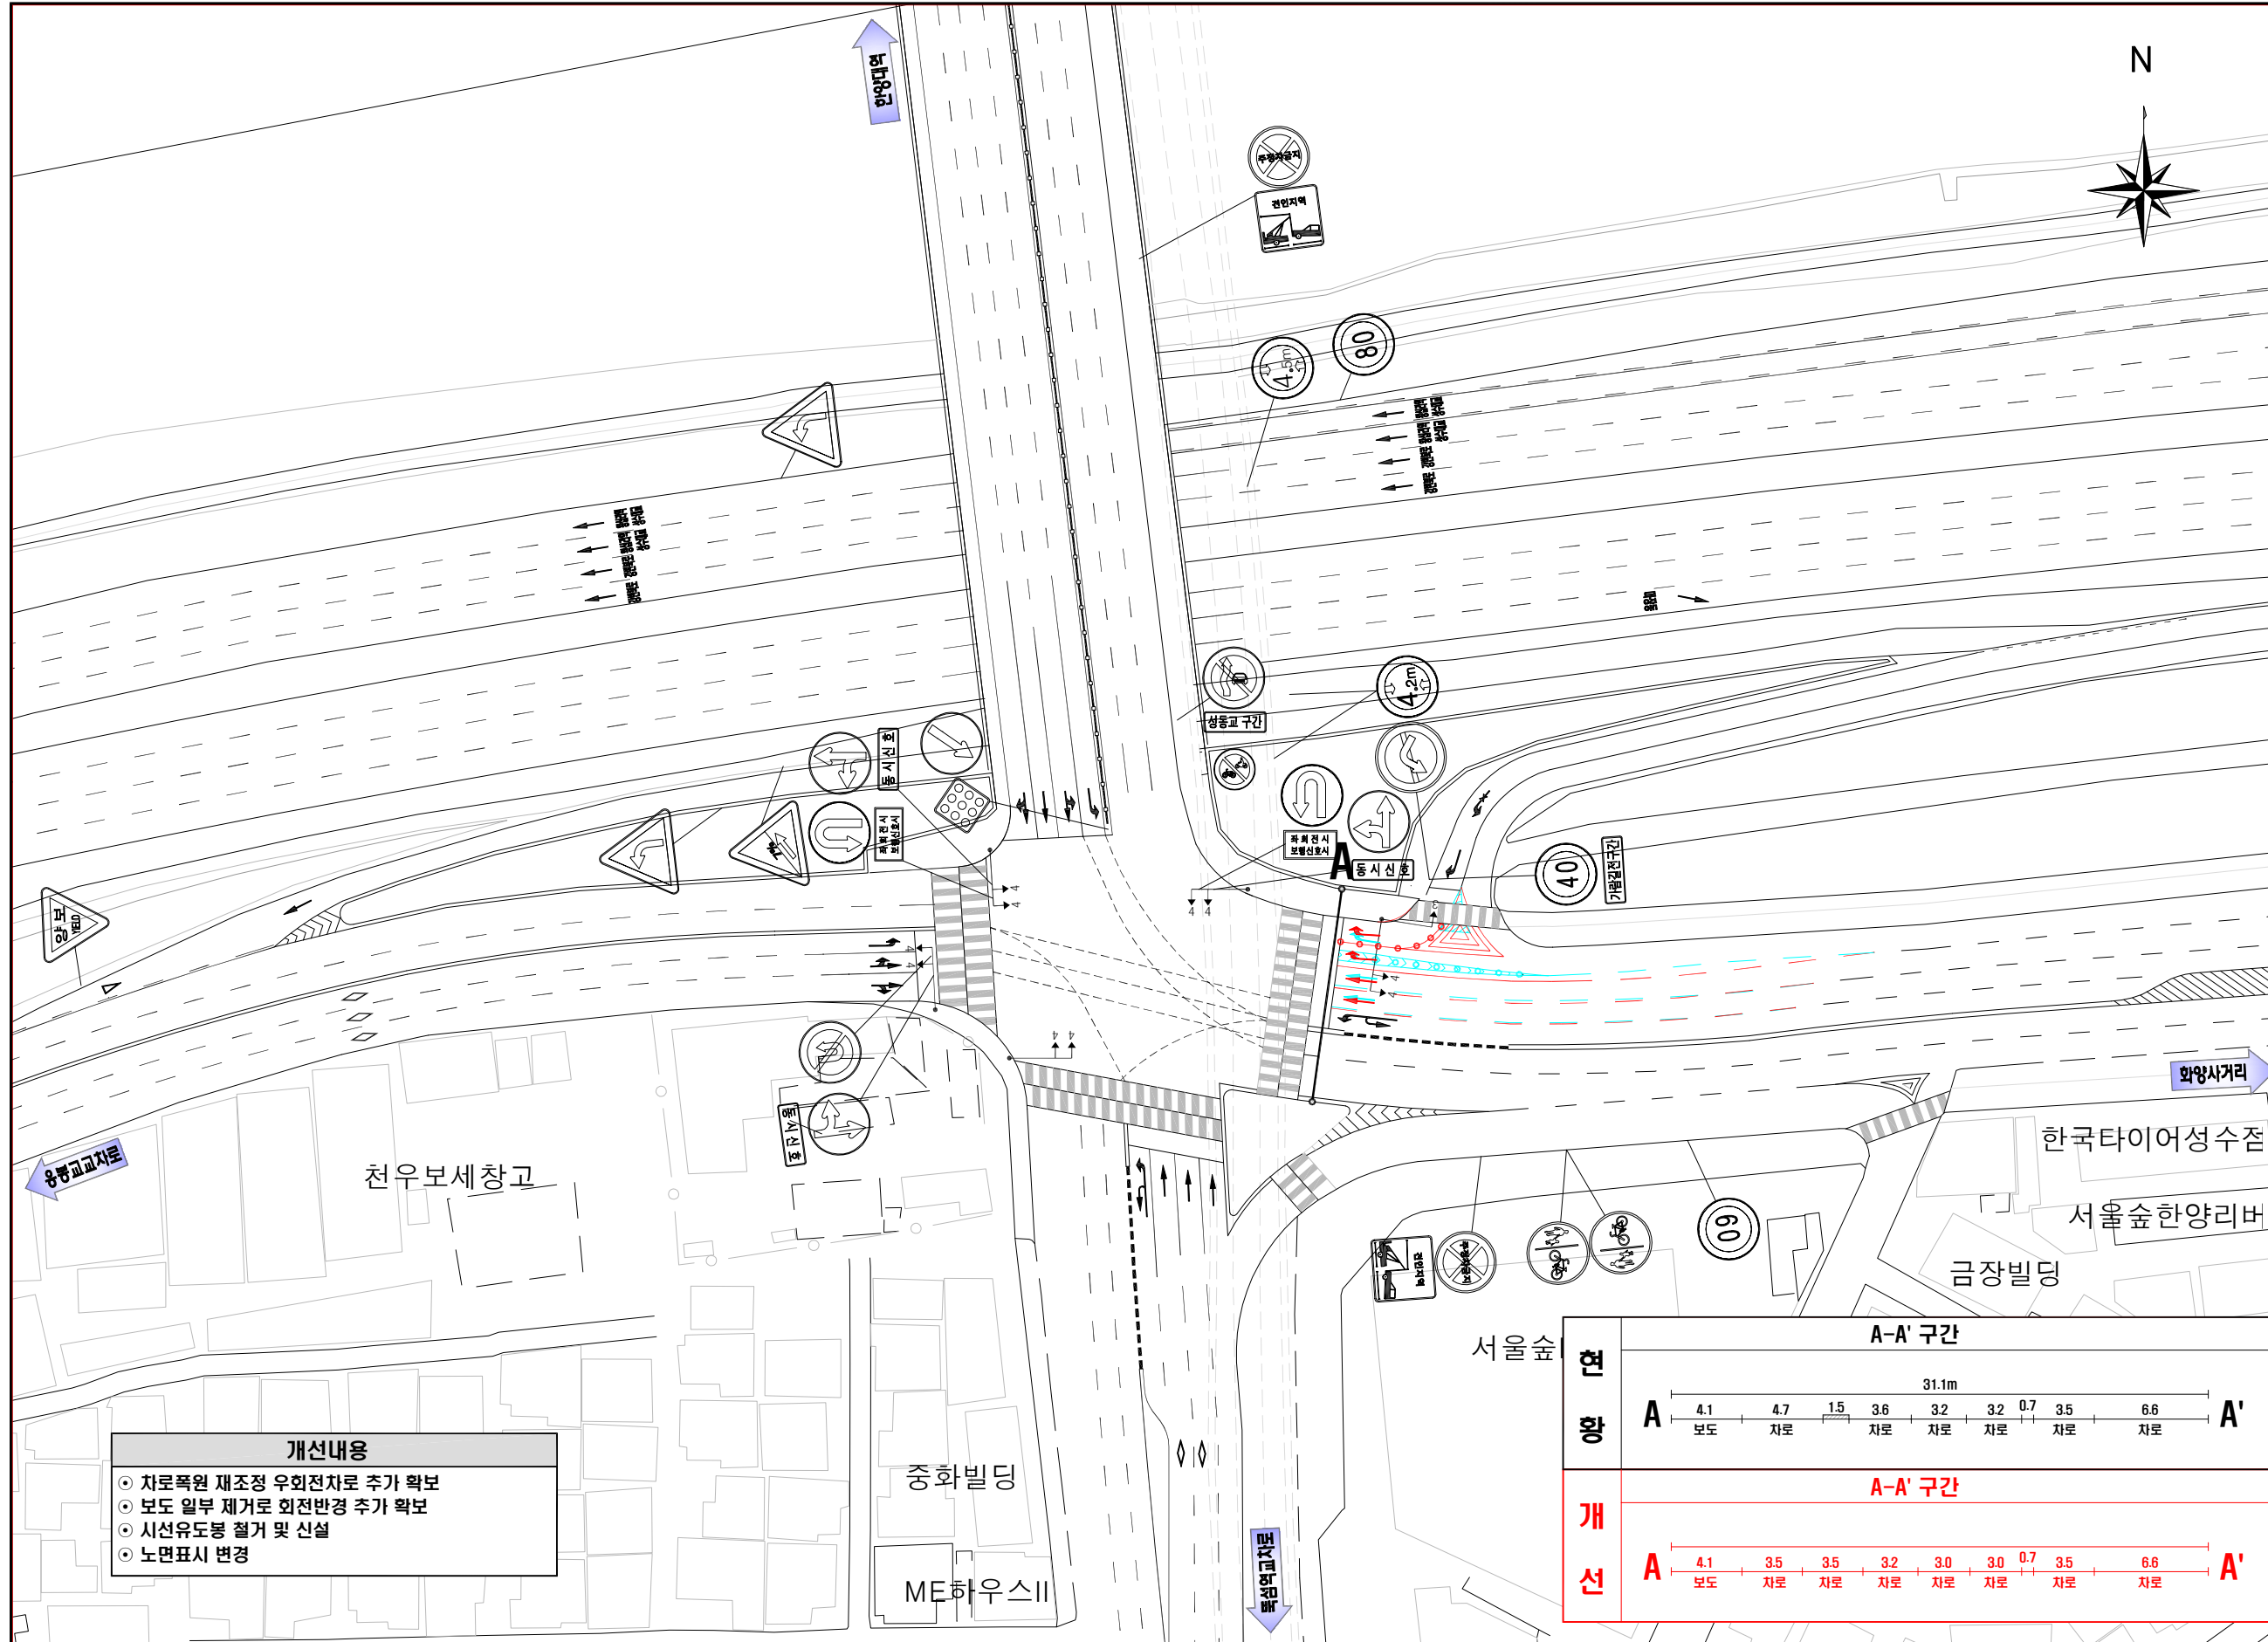
- 개선내용**
- 차로폭원 재조정 우회전차로 추가 확보
  - 보도 일부 제거로 회전반경 추가 확보
  - 시선유도봉 철거 및 신설
  - 노면표시 변경

구분	평균제어지체(초/대)	서비스수준
현황	72.6	E
개선	62.3	D
증감	▼10.3	-
